## Airtightness and Tensile Tests Report

Date: June 25, 2018  
Report Number: R6834-1

| <b>Test Unit Description:</b> | One (1) Ammunition Box |
| <b>Part Number:</b> | CNU 405 |

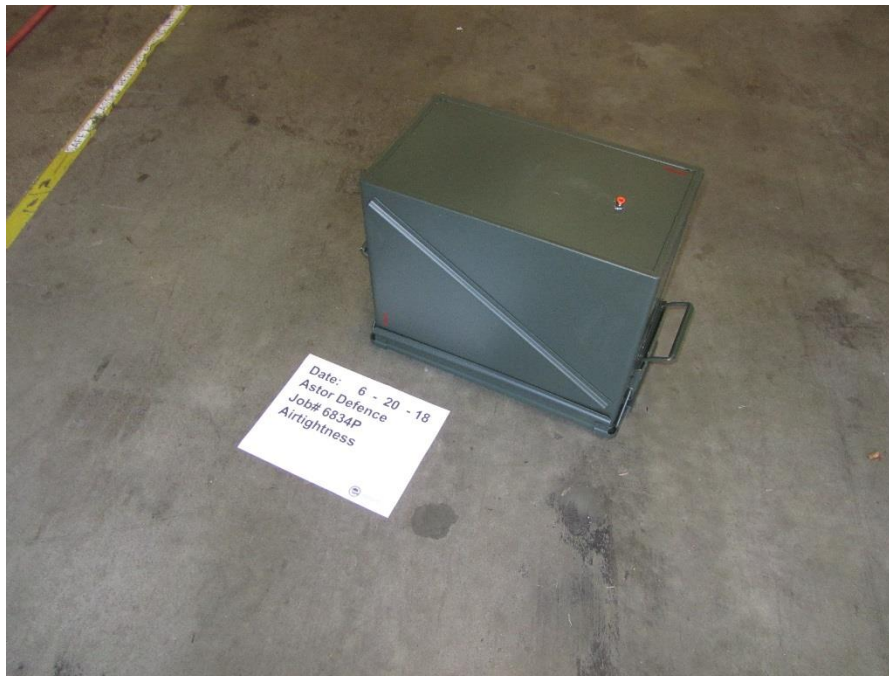
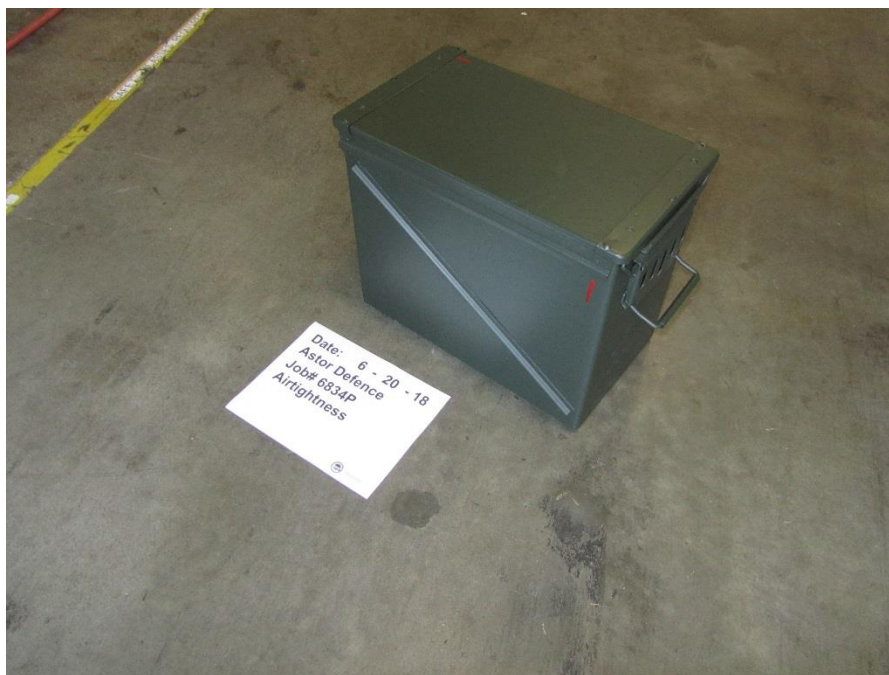
**Photo 1** – General sample condition at the start of testing

**Photo 2** – General sample condition at the start of testing

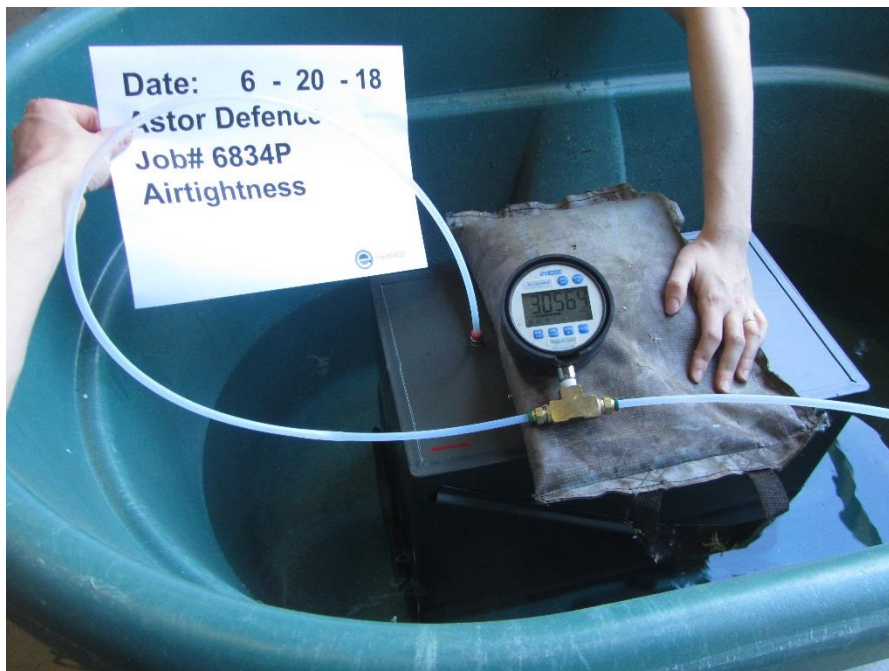
- 4.3.1 No signs of damage, deformation, discoloration, corrosion, or any other anomalies noted.
  - 4.3.1.1 No signs of bubbles observed from the sample during testing.
- 4.3.2 Test photographs provided in Appendix A.

**Photo 3** – Example of testing in progress

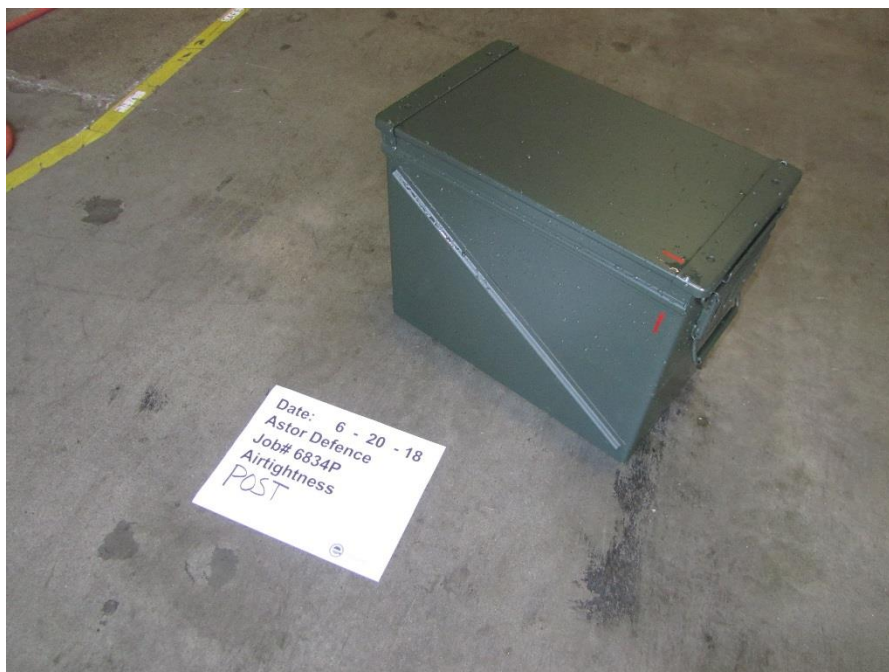
**Photo 4** – General sample condition at the end of the test

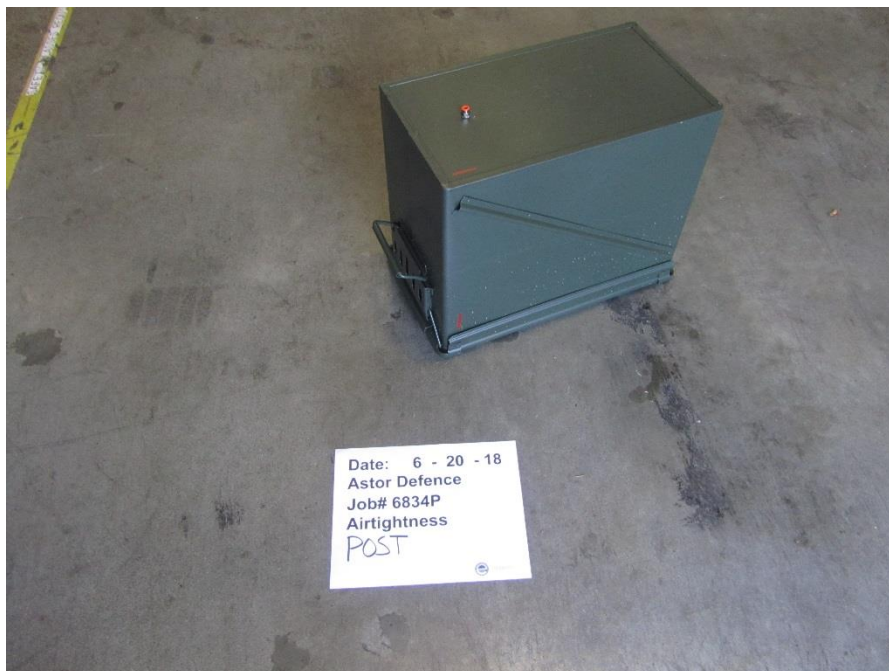
**Photo 5** – General sample condition at the end of the test

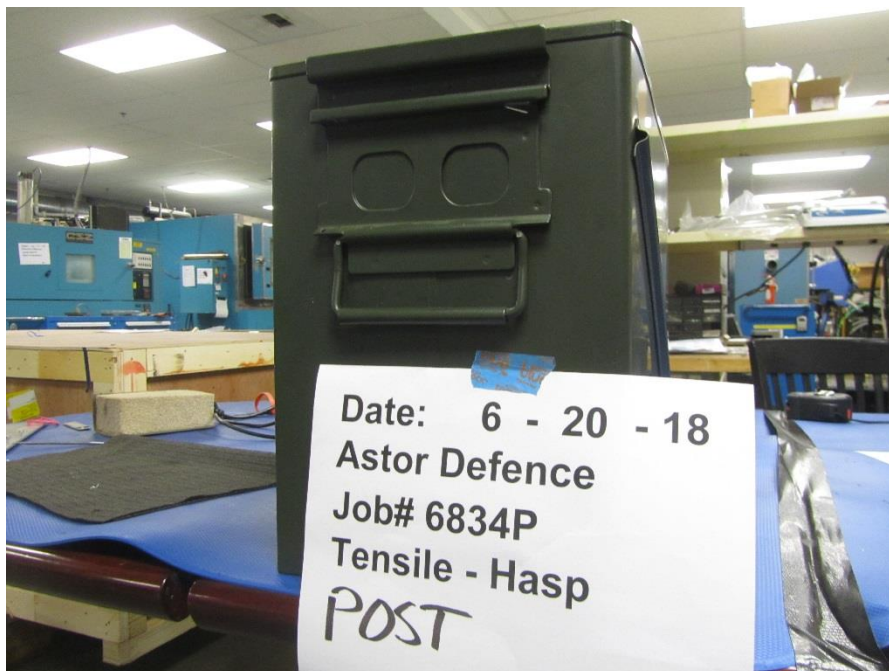
- 5.3.1 Signs of damage, deformation, discoloration, corrosion, or any other anomalies were noted.
  - 5.3.1.1 No bending or distortion observed on the sample at any portion of the test sequence.
  - 5.3.1.2 No bending or distortion observed on the sample at any portion of the test sequence.
  - 5.3.1.3 Bending or distortion observed during testing with no broken welds or detached components observed.
- 5.3.2 Test photographs provided in Appendix A.

**Photo 12** – General sample condition at the end of the test

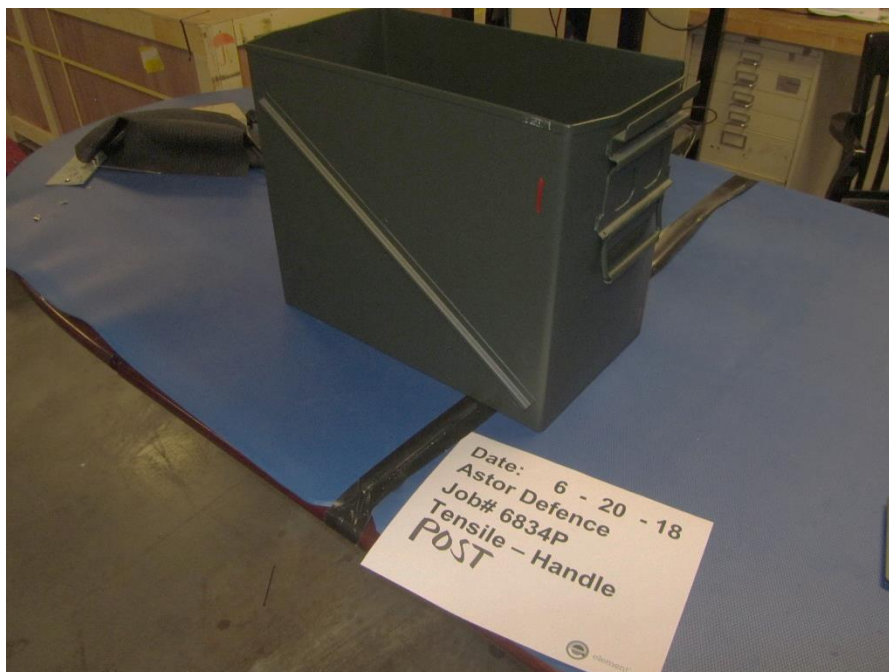
**Photo 13** – General sample condition at the end of the test

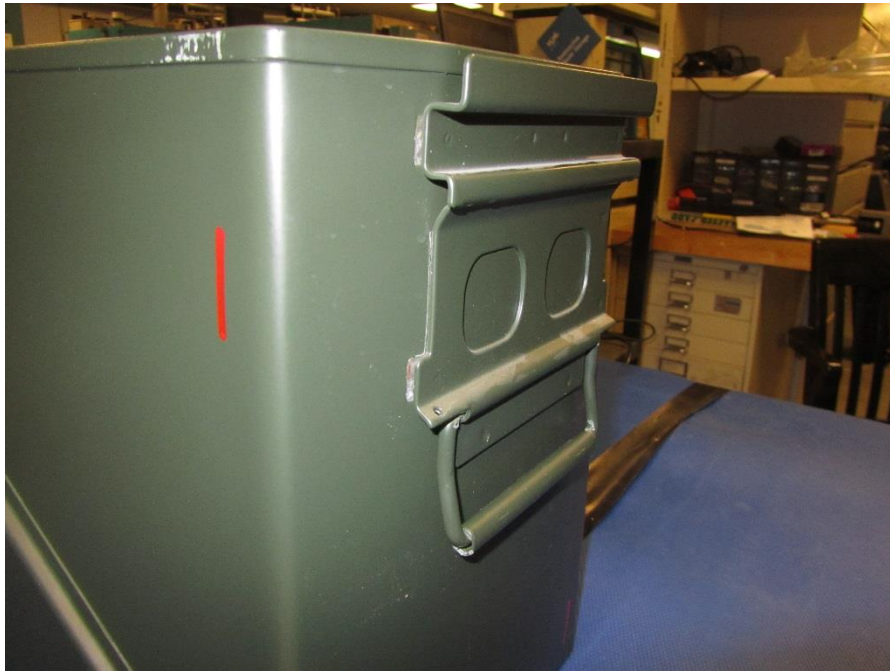
**Photo 14** – General sample condition at the end of the test
